# Mt Rosser Pond Remediation Project

## Mud Pumping Trials - Findings

Client	Rio Tinto Alcan					
Project Title	Rio Tinto Alcan Excluded Assets Remediation					
Document Title	Mud Pump trial - Findings					
Document No.	MDE0182RP0038WPR					
This Document Comprises	DCS	TOC	Text	List of Tables	List of Figures	No. of Appendices
	1	1	16	0	-	-

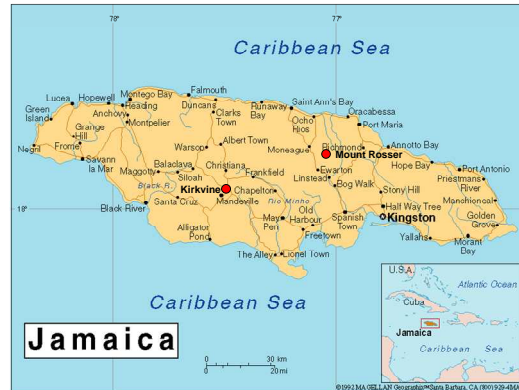
Figure 1.1

Mt Rosser Pond is a bauxite residue (red mud) tailings dam situated within the Diablo Mountains just north of the town of Eweron in Jamaica.

The “pond” is actually a man made dam which covers an area of about 40ha and has rockfill embankments of up to 53m high along the southern side that forms the impoundment. It initially constructed in 1959 to act as a tailings pond to take the bauxite residue (red mud) from the Ewarton Plant situated about 5km away and 300m lower. The red mud was pumped as a slurry comprising about 20% solids to the pond over a period of about 32 years up to 1991 when the pond was replaced by the Charlemount Mud Stacking and Drying Facility. During this period the pond embankments (referred to as dams), were raised up to 7 times providing a final crest elevation of 472m. The pond was however never filled to its final design capacity and the mud beach level remained at about 469m and the central area about 458m leaving a concave depression which held about 1.4mil m<sup>3</sup> of water with elevated pH and some caustic content.

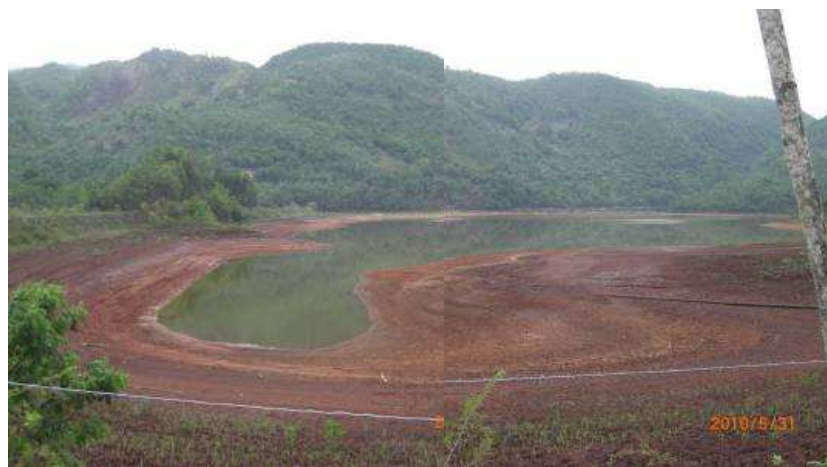
Photo 1.1: Mt Rosser Pond looking from the south-east corner to the north-west

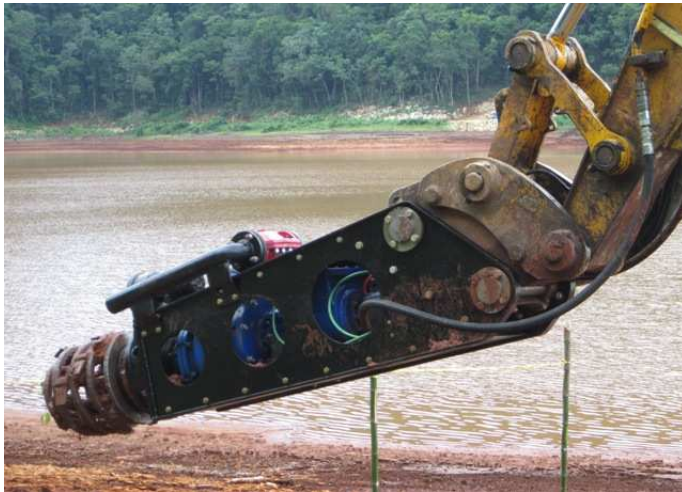
PHOTO 3.1: Eddy Pump in Excavator Attachment

The mud pumping trial was undertaken using a 4" Eddy Pump. This pump was recommended due to its ability to handle variable solids and robust operating mechanism. The pump unit incorporated a hydraulic drive and cutter head. The unit was mounted onto the boom of a JCB 220 excavator which also supplied the hydraulic feed to power the pump for the required range of 30-40 gpm at 3,500 to 4,000 psi (24-28MPa). The cutter head was powered by a standalone hydraulic power unit capable of providing the required 30gpm at 200psi (1.9 l/s at 13.8MPa). If mounted on a 30 ton excavator with a System 14 hydraulic system and duel auxiliary feeds to the boom, all necessary hydraulic power for the pump and cutter head can be supplied by the excavator. This equipment was however not available at the time in Jamaica.

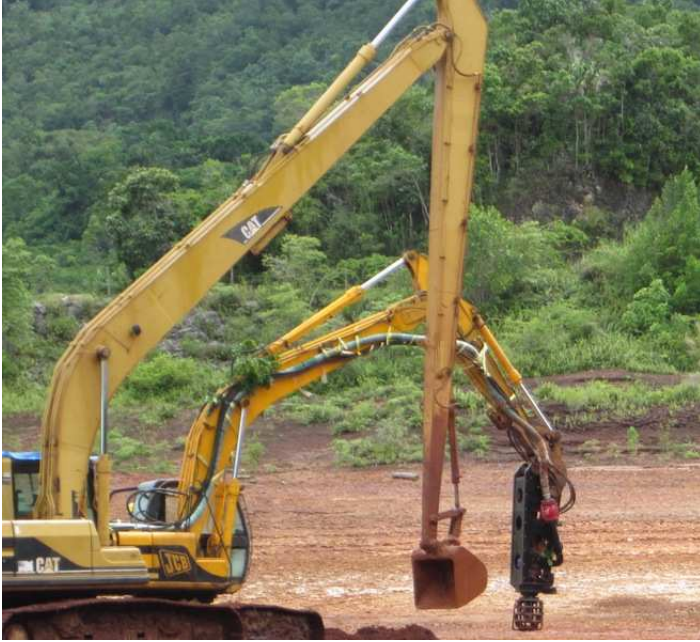
Photo 3.2: CAT 325 Long reach (60ft boom) and JCB220 with Eddy mud pump.

In addition to the pump mounted on the excavator a Long Reach excavator (CAT 325) was used to move muds towards the cutter head but also to loosen up the muds and mix in additional water to facilitate pumping. Water was added by pumping it directly from the pond using a 3" diesel water pump.

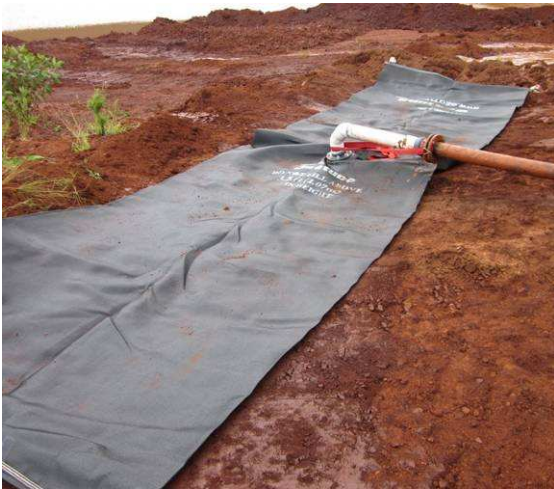
Photo 3.2: Geotube prior to filling

The geotubes for the trials were 6m long and 1m high (filled) and were supplied by Tencate. The tubes were made from a woven polyester - GT1000M and had a central top filling point. A set of small bags with a polymer test set was also provided but this was not tried during this occasion.

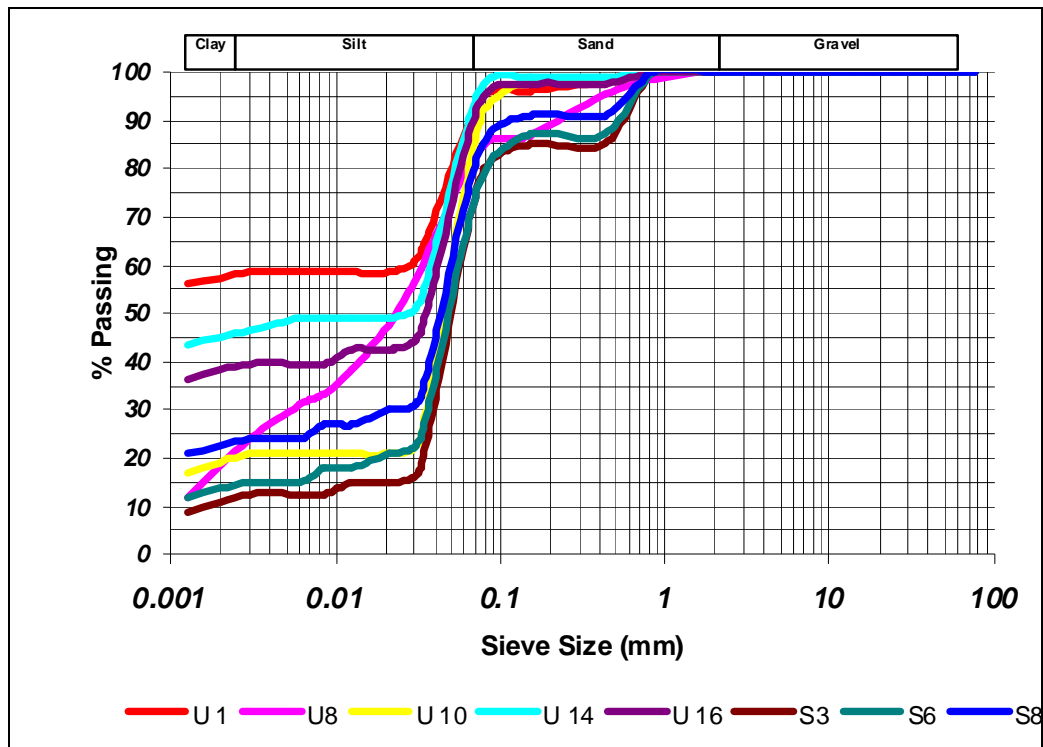
Figure 4.1: Grading analysis (conventional soil mechanics method, 2004 SI)

A geotechnical soils investigation was undertaken on the muds within Mt Rosser pond in 2004. It showed the material to be predominantly clayey silt with approximately 13% sand, 29% clay and 58% silt using conventional sieve analysis and hydrometer. Atterberg limits indicate that the material is an intermediate to high plasticity clay. The muds do however vary across the lake and also vertically. This is mainly as a consequence of the deposition process and discharge location. Close to the discharge location the courser materials would settle out first and the finer materials would disperse furthest and to the opposite end of the pond. The results are presented in figure 4.1.

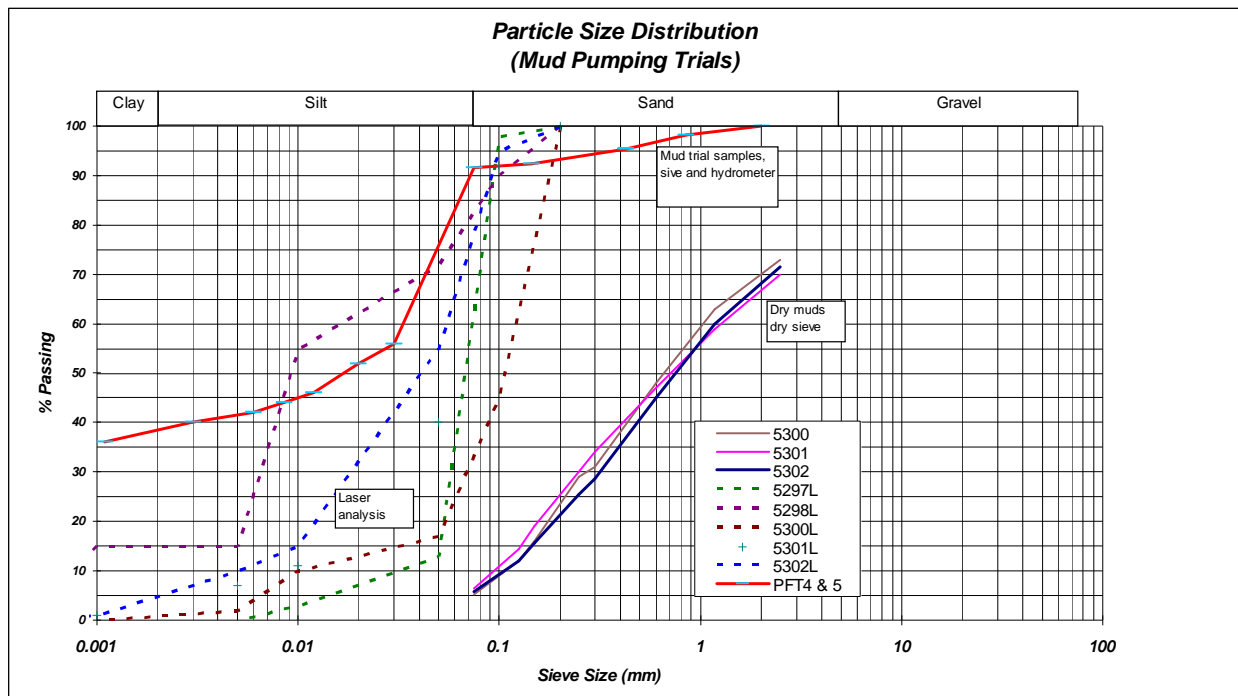
Figure 4.2: Grading analysis of dry muds using dry sieving (5300-2), wet muds using sieving & hydrometer (PFT) and laser analysis (L suffix).

Earlier this year, additional mud samples were tested as it was evident that standard soil mechanics tests did not provide an accurate assessment of this fine material. This was particularly evident in tests done with dry sieving which shows the material as well-graded sand (see results for samples 5300, 5301, 5302 on figure 4.2). When dispersed in water, even with an agent, the 'yield-pseudo-plastic' rheology of the muds appeared to affect the hydrometer results with large variations between tests (see results of samples PFT4&5 taken during mud pumping trials on figure 4.2).

The additional testing comprised of undertaking gradings using a Laser Particle Analyzer. The results indicated that the muds are predominantly Silt although the silt % varied from 30% to 80% with the

material being either more sandy or more clayey (up to 15% clay). See results of samples ending in “L” on figure 4.2 below.

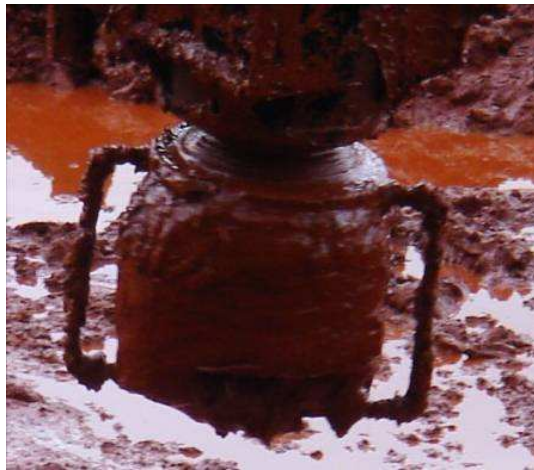
Photo 5.1: Cutter head blinded with mud

Initially pumping was problematic mainly due to the excavator being underpowered. This was diagnosed as a hydraulic pump problem and the excavator was replaced. The cutter head (which also acts to protect the intake) tended to blind with mud (Photo 5.1) and was also not providing enough agitation to liquefy the muds. This was partly resolved by adding “stirrers” (2 steel loops welded either side) to the rotating cutter head and also a “comb” (Photo 5.2) to keep the gaps within the cutter head open.

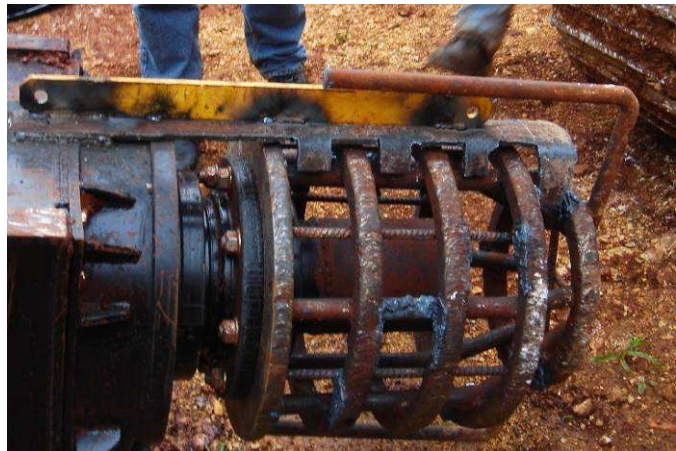
Photo 5.2: Cutter Head With Comb added

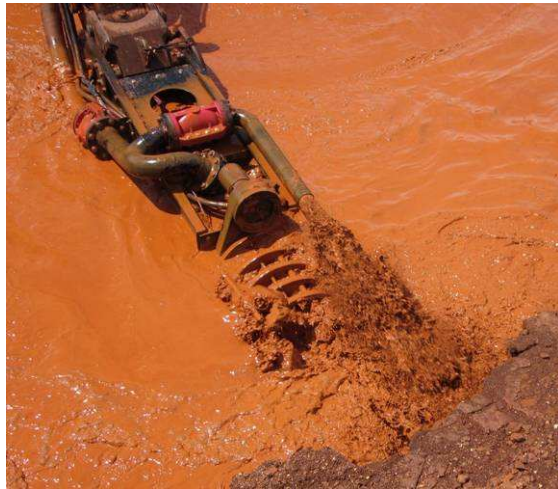
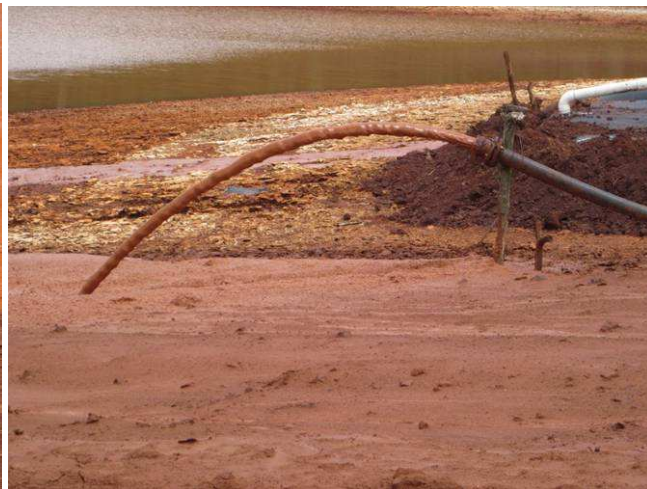
Photo 5.3: Mud pump in re-circ / priming mode    Photo 5.4: Discharge of muds ( $\pm 30$ l/s,  $\pm 37\%$  solids)

As mentioned previously, the long reach excavator was used to loosen up the muds. Water was pumped from the pond using a 3” pump into the excavation and the long reach would then work the muds to mix the water in. The mud pump would then be used in recirculation mode to further mix the muds into a more consistent state. Even with this mixing and agitation, the water tended to concentrate on the surface. This aided the initial process of priming the pump and once primed thicker muds at 1m to 2m below the surface could be pumped. However, it was found that the deeper muds tended to be lumpy and this would significantly reduce or stop the flow requiring the pump to be lifted into thinner muds or having to go back into re-circ mode or having to fully re-prime. The pump discharge was therefore very

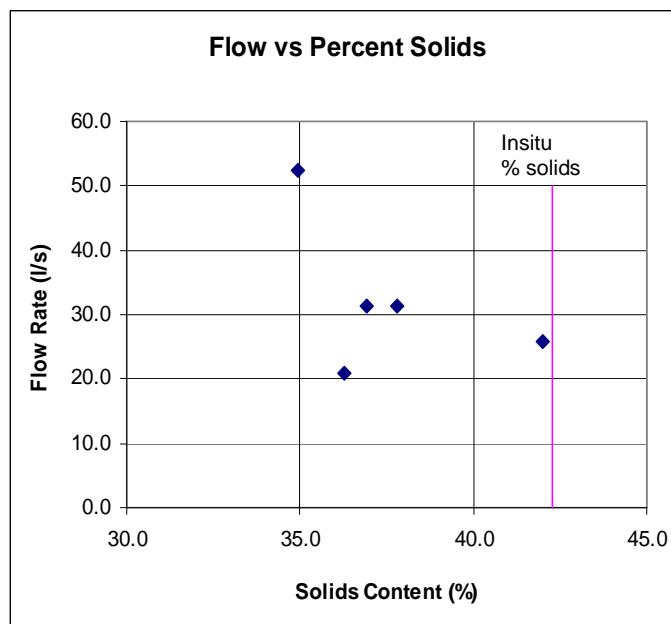
Figure 5.1: Graph of Flow rate at various solids content

Mud pumping rates varied from 21 l/s to 52 l/s (332 - 824gpm) and it was clearly visible that the more liquid the muds were the higher the pump rate was. Samples were taken at different discharge rates and moisture content and percent solids determined by laboratory testing. The results are plotted in Figure 5.1 and although scattered, do give an indication of the effects of solids content on flow rates. The natural moisture content of the muds (insitu) at the test location was 137%, or 42% solids. This is shown in Figure 5.1 as a vertical line. Pumping muds close to the percent solids was achieved although flow rates were low.

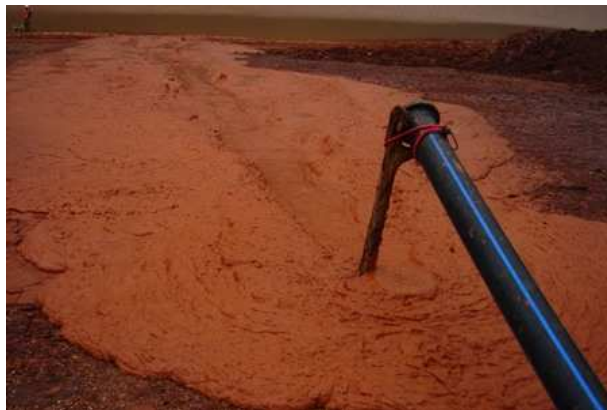
Photo 5.5: Mud discharge point

Discharge of the pumped muds was through 30m of flexible hose then 60m of 4" HDPE pipe which had an internal diameter of about 87mm (3.5"). The muds were discharged onto the original mud beach which lies at a gradient of about 9%. On deposition the muds slowly flowed down gradient. At times the flow would stop and the muds would build up then flow again in a wave motion. The natural angle of repose would therefore be a few degrees less than this – probably 5% to 6%.

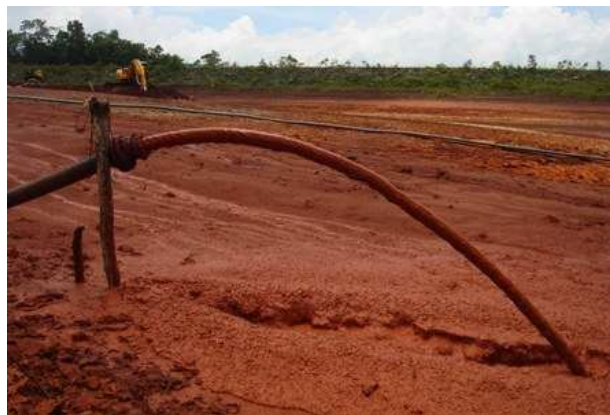
Photo 5.6: Muds being discharged

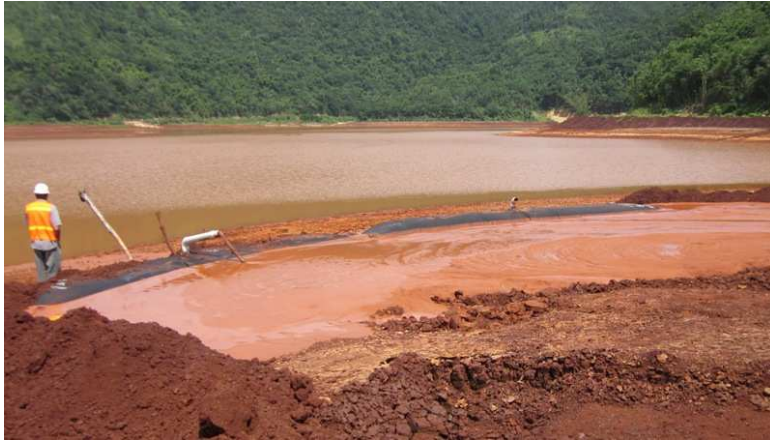
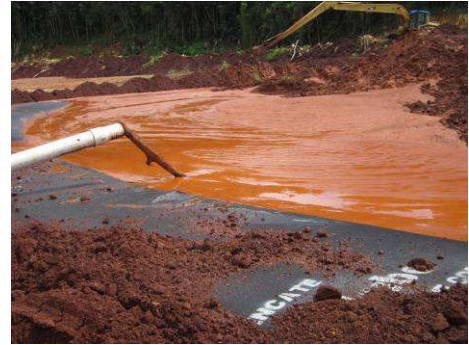
Photo 5.7: Two geotubes forming the bund of the trial pond

Photo 5.8: Muds after pumping are liquid

Tube 1 was filled initially with more runny mud and then thicker muds as the pump operator got a better feel for conditions. The tube was filled until firm. The second tube was filled with thicker muds and filling continued until the tube was taut. These two tubes were positioned on the sloping beach in order to form a small “U” impoundment area that would later be filled with pumped muds. Although the area was prepared, the sloping ground caused the first tube to rotate through about 20 degrees. The tube was staked and the downslope side backfilled. A more defined bed was created for the second tube and the same rotational issue was limited. The two filled tubes with the ponded mud are shown in Photos 5.7 and 5.8. Other than a small leak at the contact between the two geotubes, the ponding of the muds was successful.

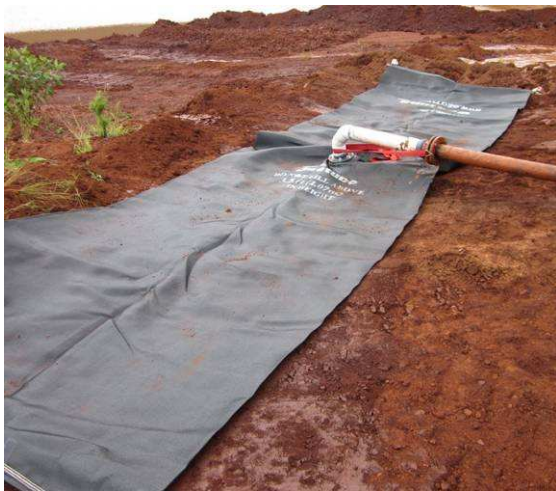
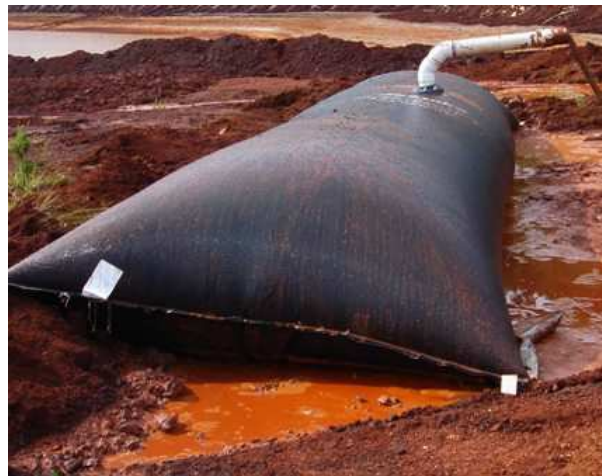
Photo 5.10: Geotube prior to filling

Photo 5.11: Geotube filled taut – note seepage /bleeding

In all three cases, there was very little mud loss or seepage from the tubes. When stood on, some red water would squeeze out around the pressure area. Once filled taut, the entire bag would have small red water droplets form on the outside (visible in Photo 5.11) , but the seepage was in general nominal.

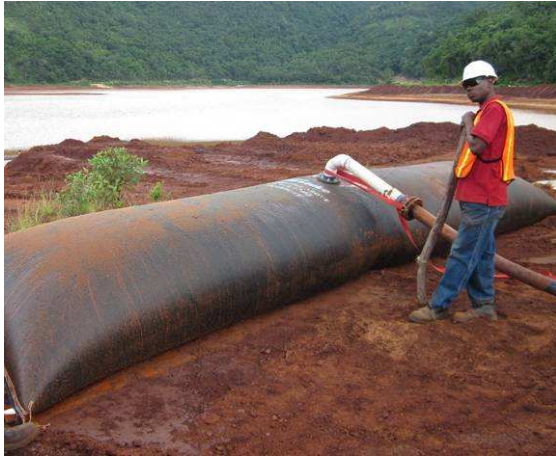
Photo 5.12: Geotube #3 filled to capacity

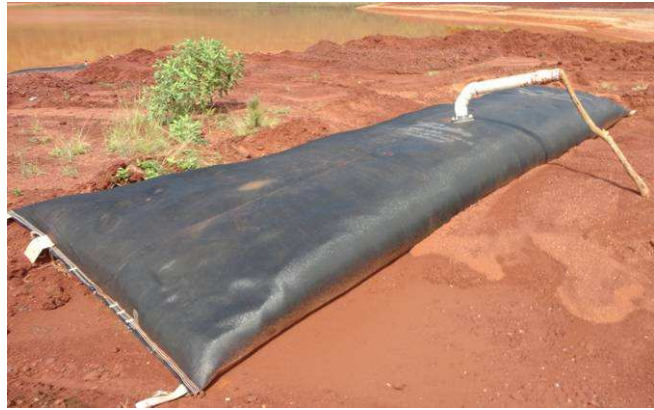
Photo 5.13: Geotube #3 after 6 weeks

The tubes have been monitored and the most recent photo's taken on 10 October 2011 (6 weeks after filling) show how the tubes have reduced in volume due to the dewatering of the contained muds. Volume loss is estimated to be around 30%. The anticipated moisture content would therefore be about 90% and the solids around 53%.

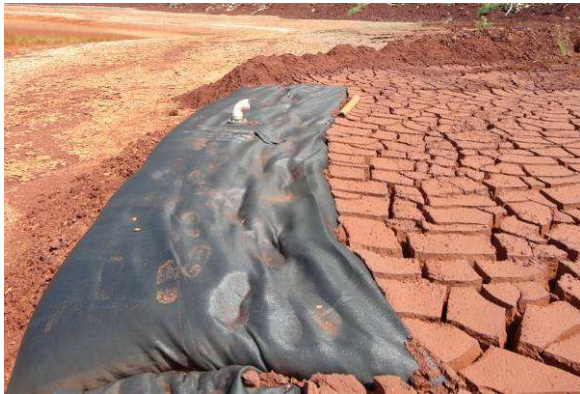
Photo 5.14: Geotube #4 after 6 weeks

The muds pumped into the trial pond behind the geotubes were medium thick to thick, probably in the order of 37 - 40% solids. After 6 weeks the mud has not only firmed-up but had dried out significantly with wide and deep surface cracks as are evident in Photo 5.14 and 5.15.

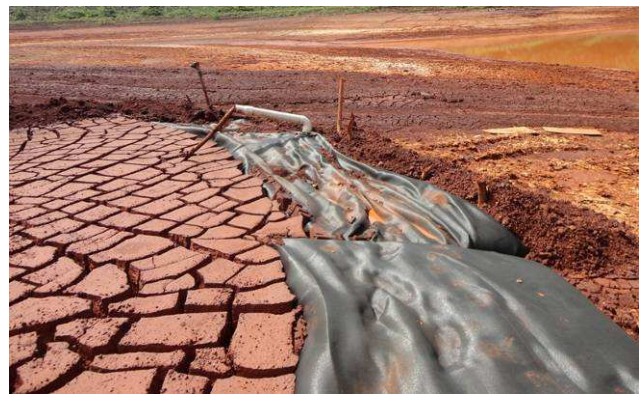
Photo 5.15: Geotube #1 after 6 weeks
